Inspectors Initials JB Property Address 2810 Ocean Shore Blvd, Units 1-13 Ormond Beach 32174

# Uniform Mitigation Verification Inspection Form

| Inspection Date: Oct 19, 2018 | | |

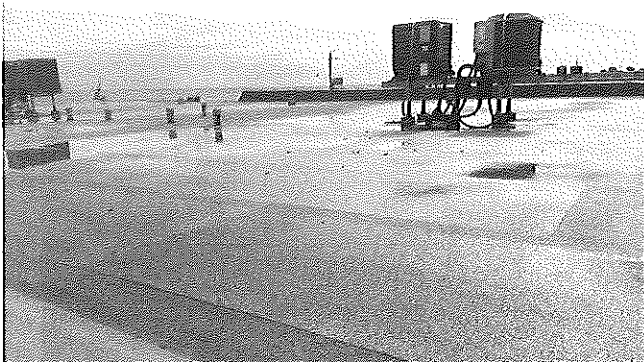
| 2.1 Roof Covering Type: | Permit Application Date | FBC or MDC Product Approval # | Year of Original Installation or Replacement | No Information Provided for Compliance |
|---|---|---|---|---|
| <input checked="" type="checkbox"/> 5. Membrane | 11/16/17 | _____ | 2017 | <input type="checkbox"/> |

- ☒ A. All roof coverings listed above meet the FBC with a FBC or Miami-Dade Product Approval listing current at time of installation OR have a roofing permit application date on or after 3/1/02 OR the roof is original and built in 2004 or later.
- ☐ B. All roof coverings have a Miami-Dade Product Approval listing current at time of installation OR (for the HVHZ only) a roofing permit application after 9/1/1994 and before 3/1/2002 OR the roof is original and built in 1997 or later.
- ☐ C. One or more roof coverings do not meet the requirements of Answer "A" or "B".
- ☐ D. No roof coverings meet the requirements of Answer "A" or "B".
