Uniform Mitigation Verification Inspection Form

Inspection Date: 4/18/2017		
Owner Information		
Owner Name: Golf Villas One Condominium		Contact Person:
Address: 9850-9878 Perfect Drive		Home Phone: (703) 232-3700
City: Port St. Lucie	Zip: 34986	Work Phone:
County: St. Lucie		Cell Phone:
Insurance Company:		Policy #:
Year of Home: 1996	# of Stories: 2	Email: ronaldsndrs@yahoo.com

9850-9878 Perfect Drive

Don Meyler Inspections

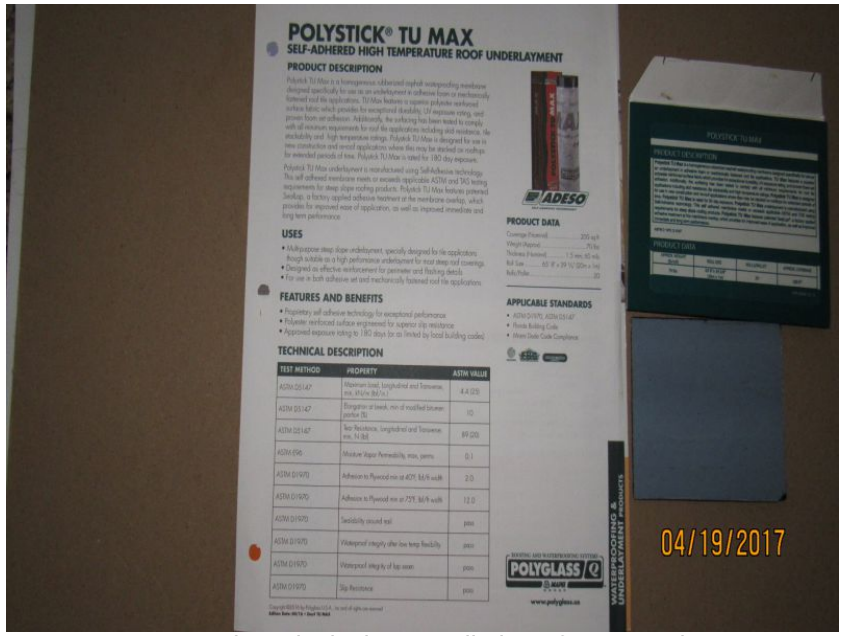
Documentation Displaying Installation of Approved SWR

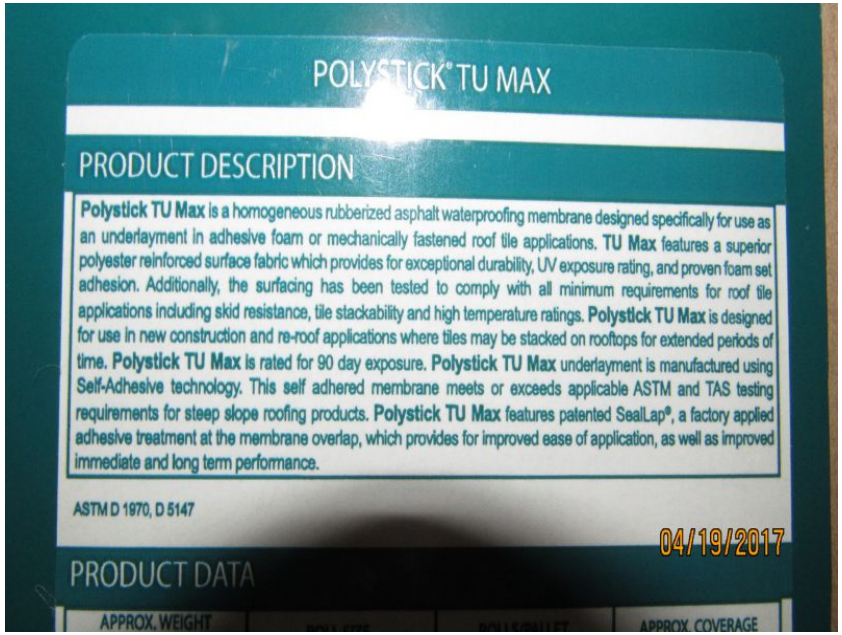
Documentation Displaying Installation of Approved SWR
