Uniform Mitigation Verification Inspection Form

Inspection Date: 4/18/2017		
Owner Information		
Owner Name: Golf Villas One Condominium		Contact Person:
Address: 9962-9990 Perfect Drive		Home Phone: (703) 232-3700
City: Port St. Lucie	Zip: 34986	Work Phone:
County: St. Lucie		Cell Phone:
Insurance Company:		Policy #:
Year of Home: 1996	# of Stories: 2	Email: ronaldsndrs@yahoo.com

9962-9990 Perfect Drive

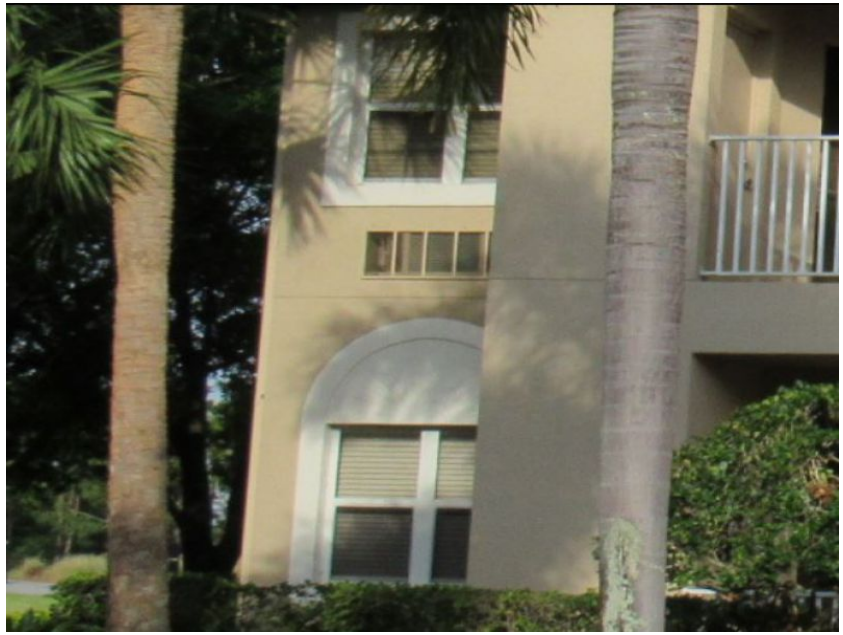
Unprotected Window

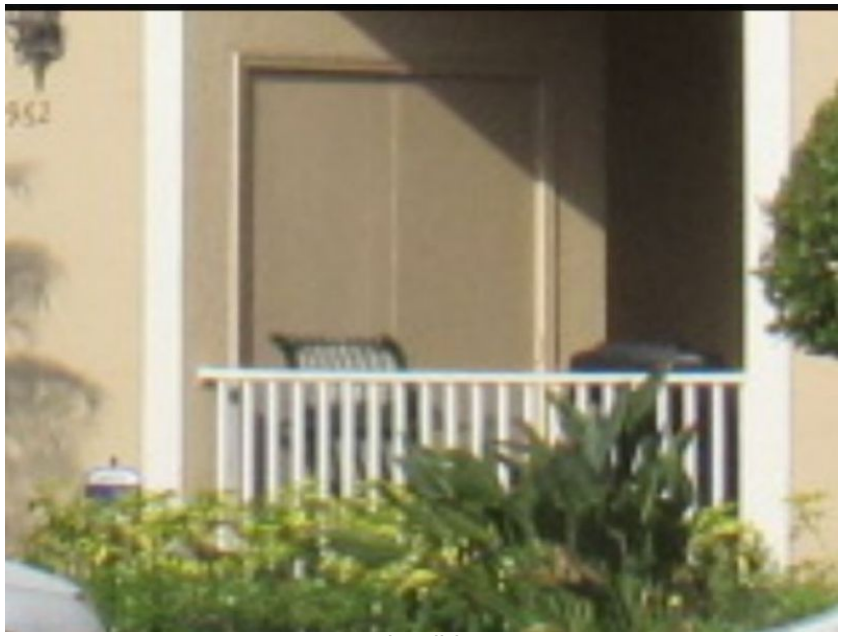
Unprotected Solid Entry Door

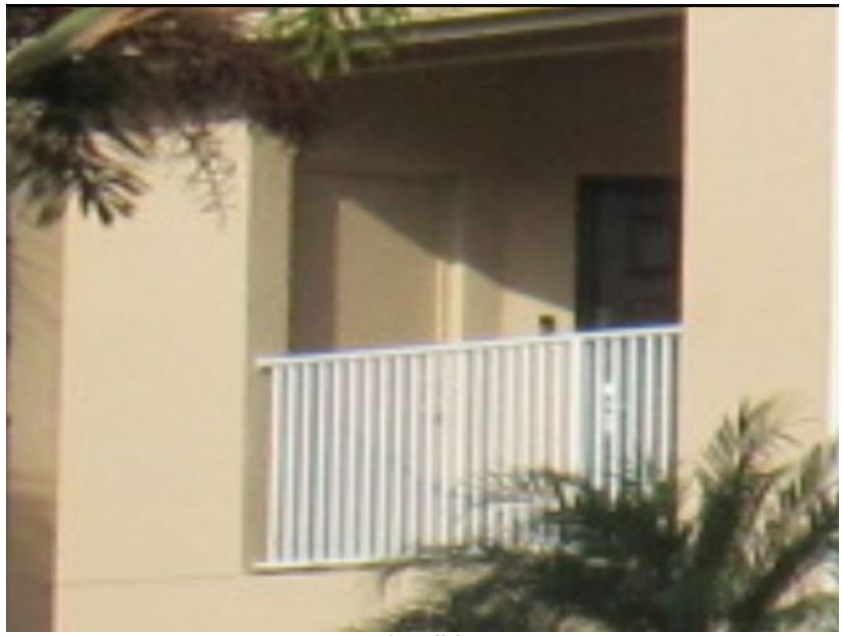
Unprotected Solid Entry Door
